# Guam Waterworks Authority (VP0989)

## CWA Collection System

Tumon, Guam

NEIC Field Investigation Photographs  
April 24 through May 4

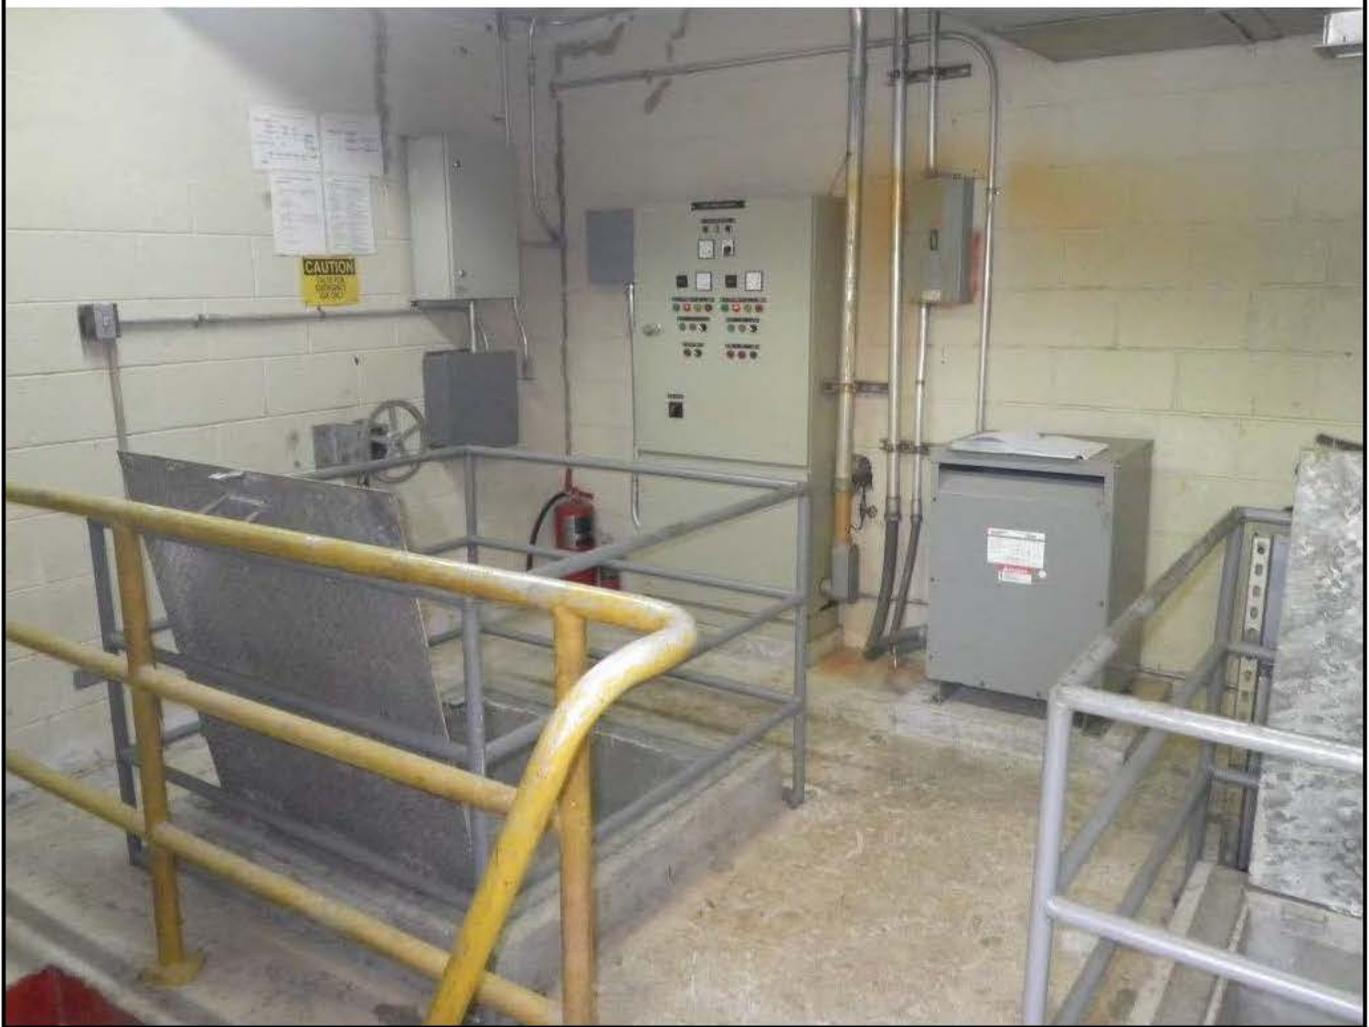
File Name: RIMG0053.JPG

Title	Guam Waterworks Authority (VP0989)
Subject	CWA Collection System
Date Time Stamp	4/27/2012 1:35:56 PM
Photographer	D. Vanlerberghe
Description	Double Trouble pump station pump control room

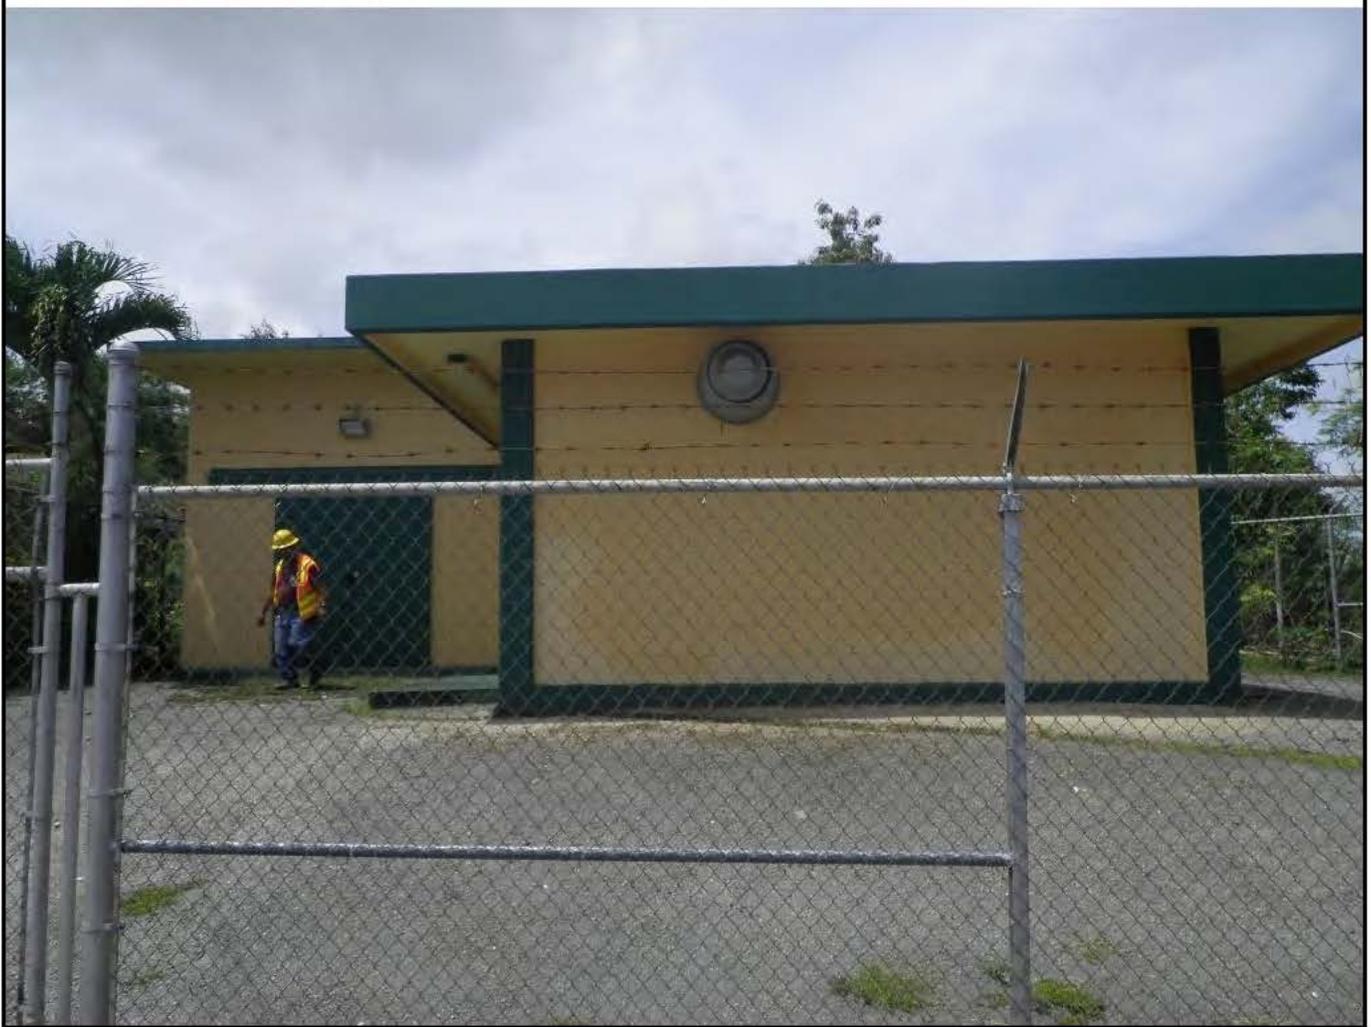
File Name: RIMG0054.JPG

Title	Guam Waterworks Authority (VP0989)
Subject	CWA Collection System
[REDACTED]	[REDACTED]
[REDACTED]	[REDACTED]
Date Time Stamp	4/27/2012 1:38:53 PM
Photographer	D. Vanlerberghe
Description	Double Trouble pump station building

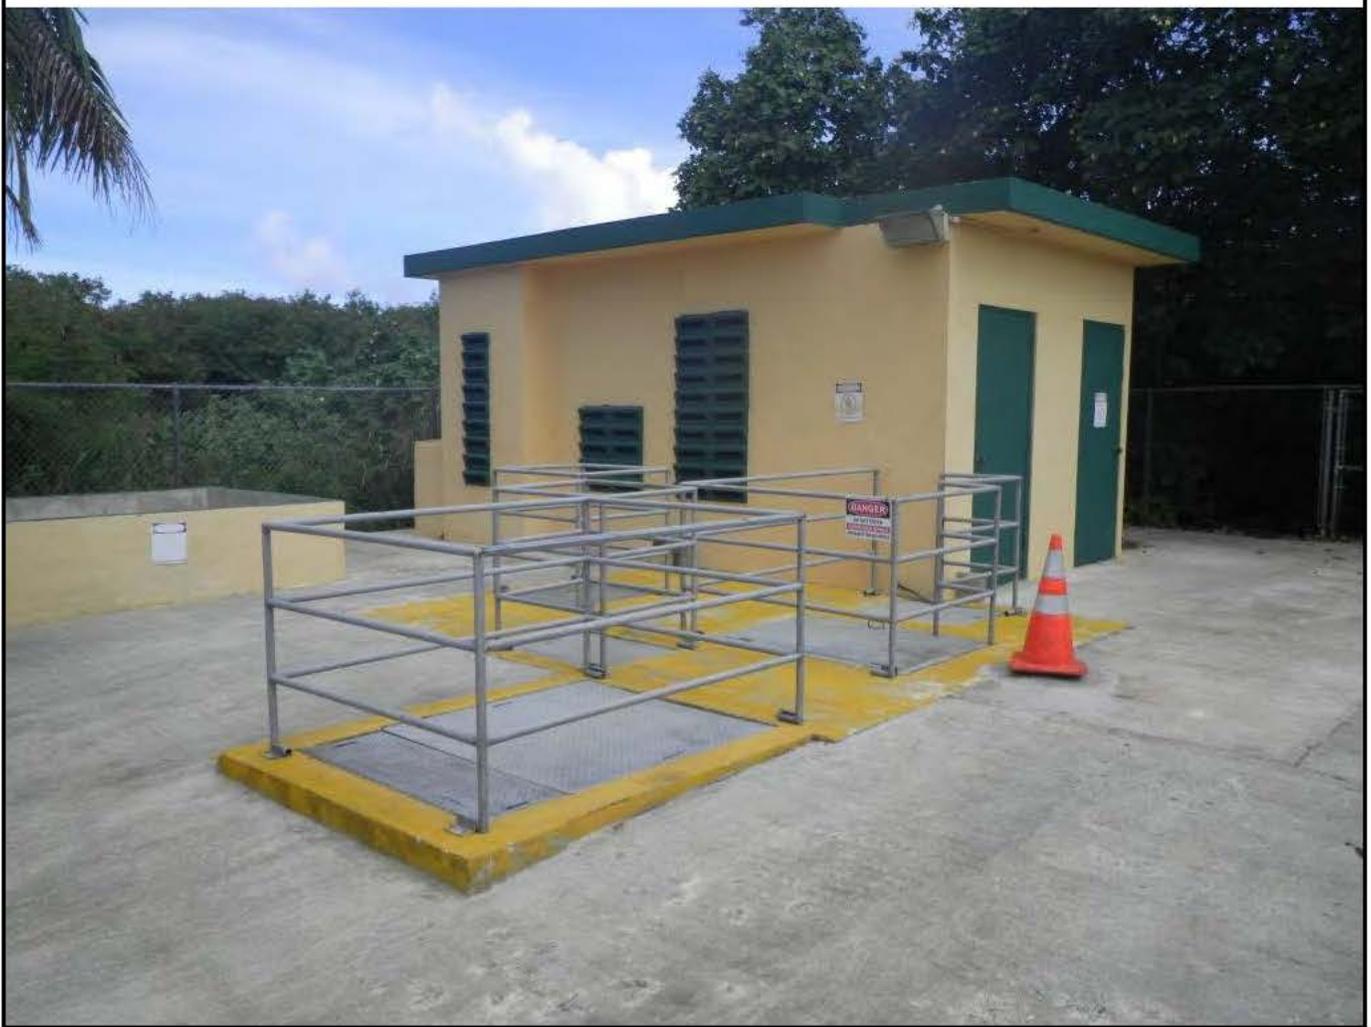
File Name: RIMG0057.JPG

Title	Guam Waterworks Authority (VP0989)
Subject	CWA Collection System
Date Time Stamp	4/27/2012 2:06:43 PM
Photographer	D. Vanlerberghe
Description	PGD pump station building

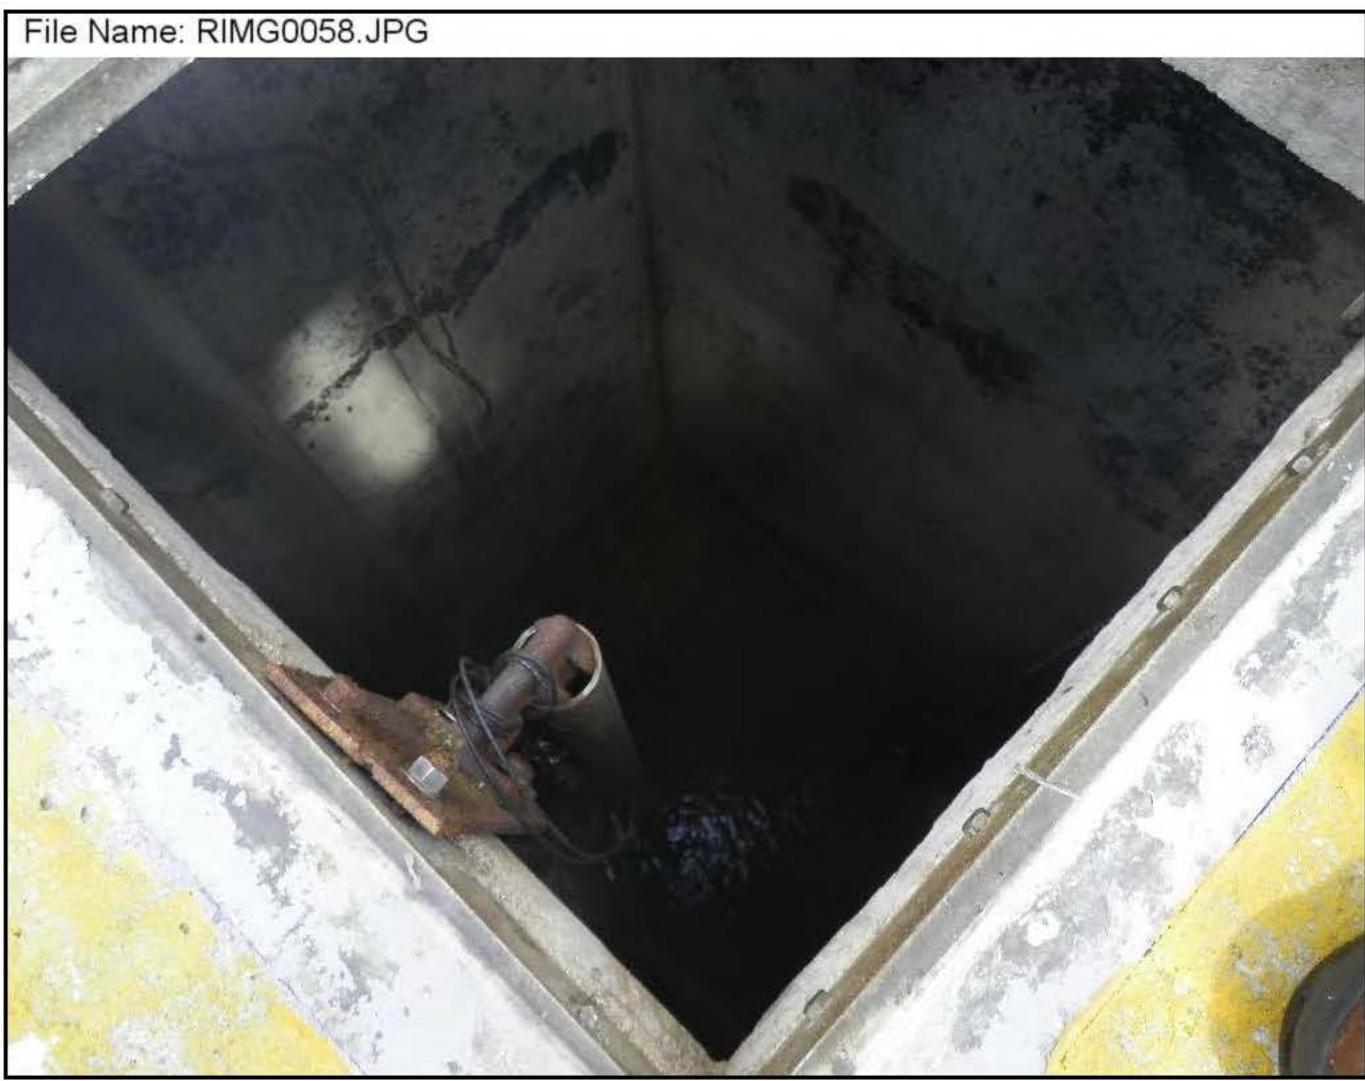
Attributes	
Title	Guam Waterworks Authority (VP0989)
Subject	CWA Collection System
Date Time Stamp	4/27/2012 2:20:56 PM
Photographer	D. Vanlerberghe
Description	Hafa Adai pump station wet well

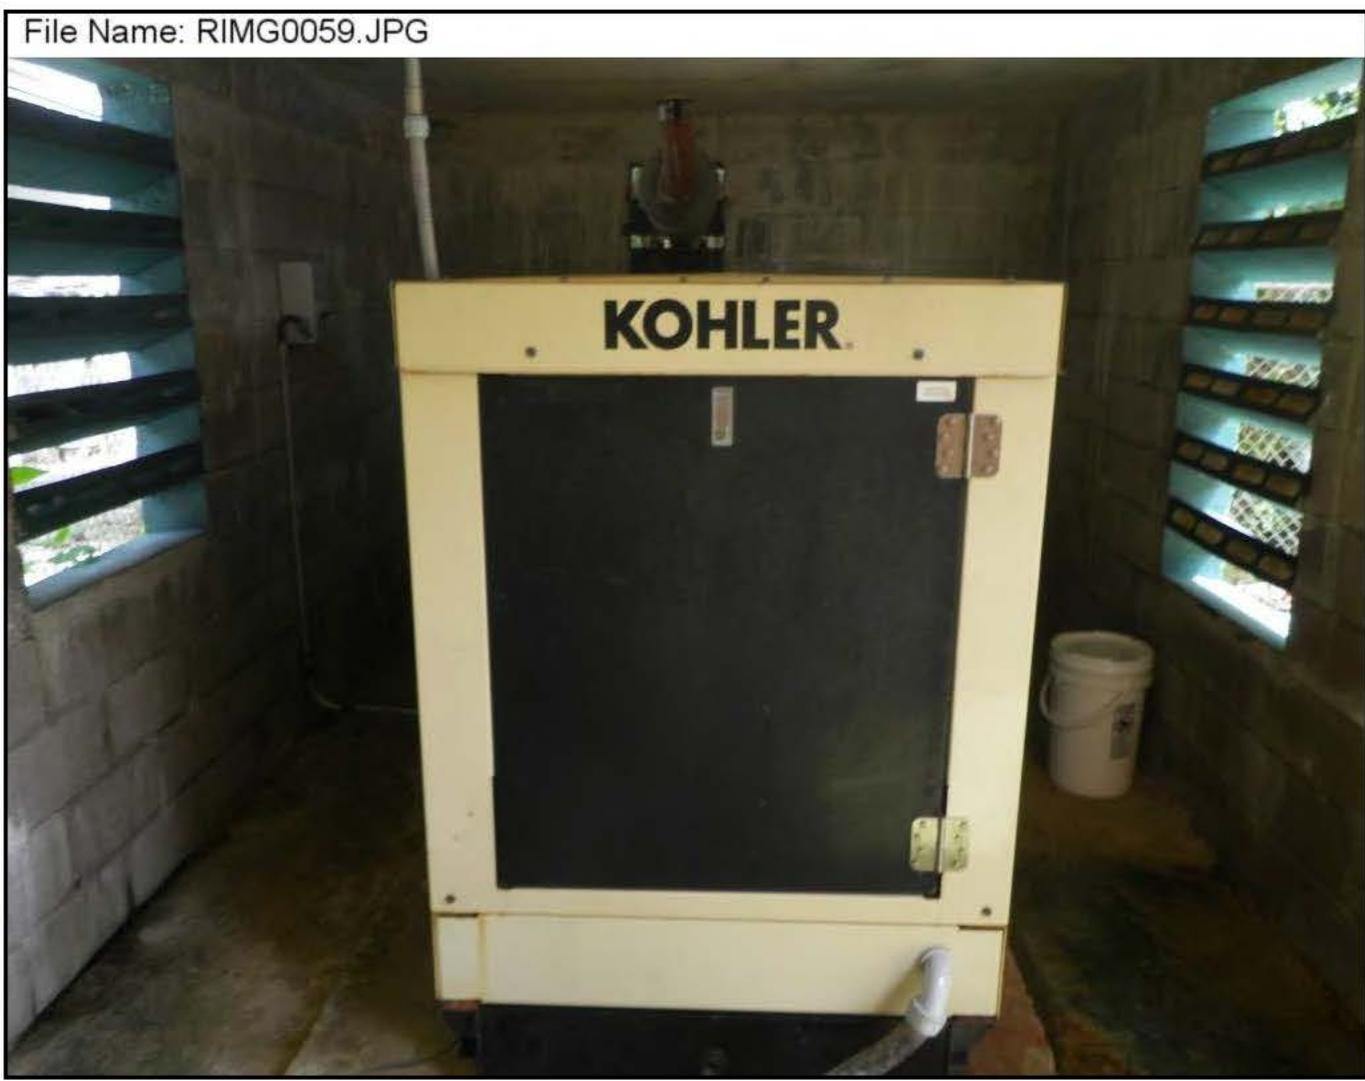
Attributes	
Title	Guam Waterworks Authority (VP0989)
Subject	CWA Collection System
Date Time Stamp	4/27/2012 2:21:40 PM
Photographer	D. Vanlerberghe
Description	Hafa Adai pump station standby generator

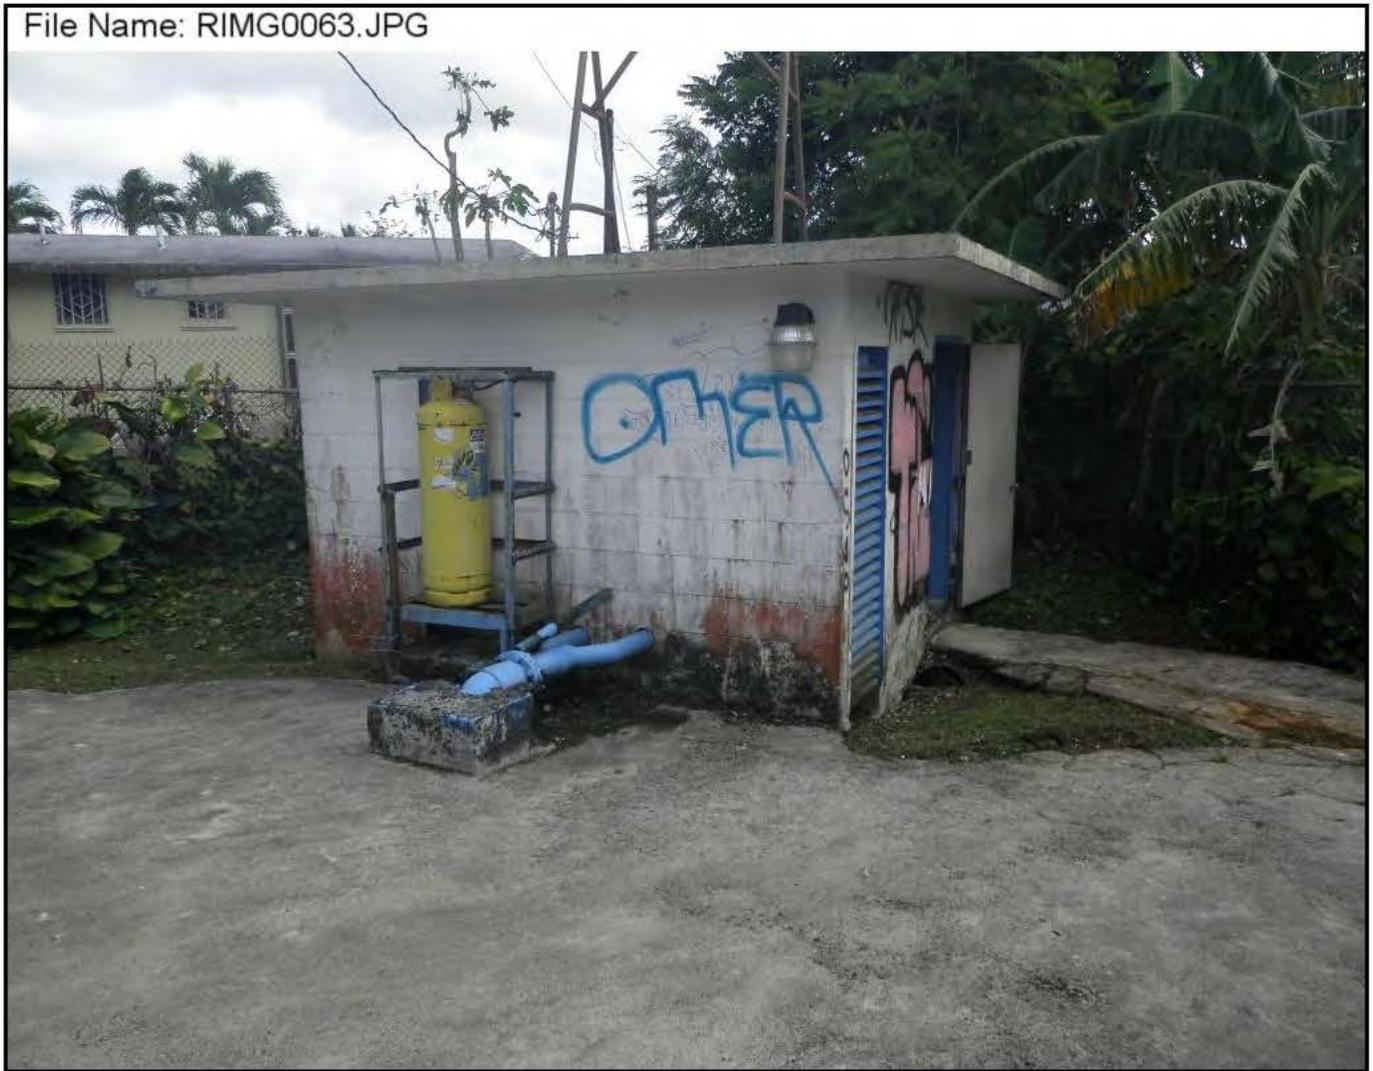
Attributes	
Title	Guam Waterworks Authority (VP0989)
Subject	CWA Collection System
Date Time Stamp	4/27/2012 2:55:24 PM
Photographer	D. Vanlerberghe
Description	Santa Ana pump station, showing liquified petroleum gas tank used in the past for the standby generator.

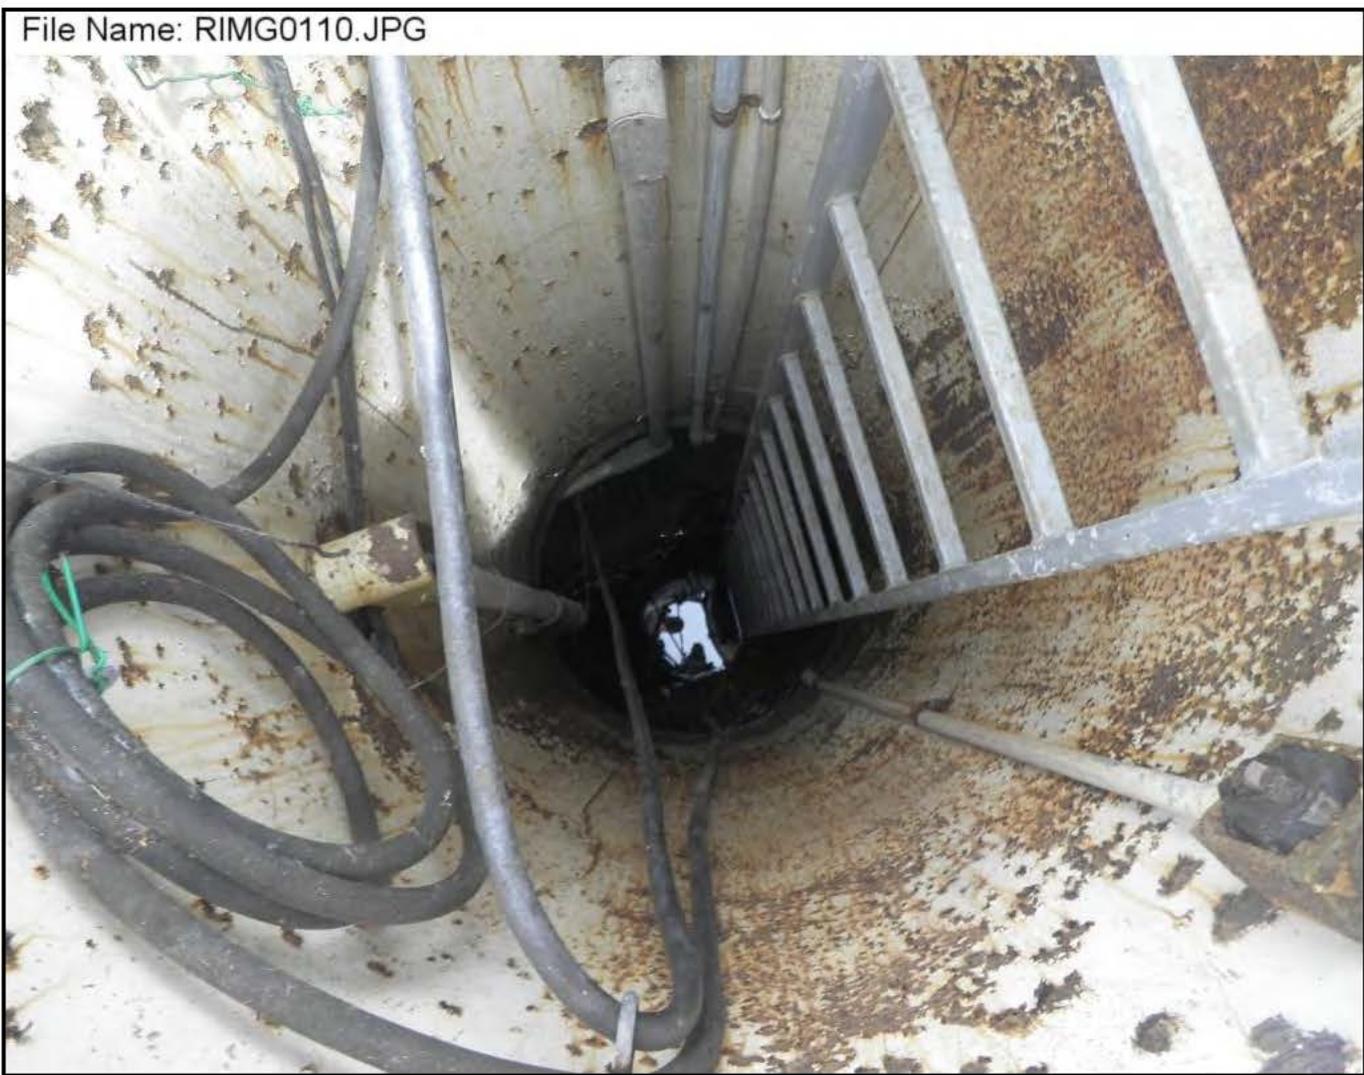
Attributes	
Title	Guam Waterworks Authority (VP0989)
Subject	CWA Collection System
Date Time Stamp	5/1/2012 11:00:07 AM
Photographer	D. Vanlerberghe
Description	Mong Mong pump station pump access.

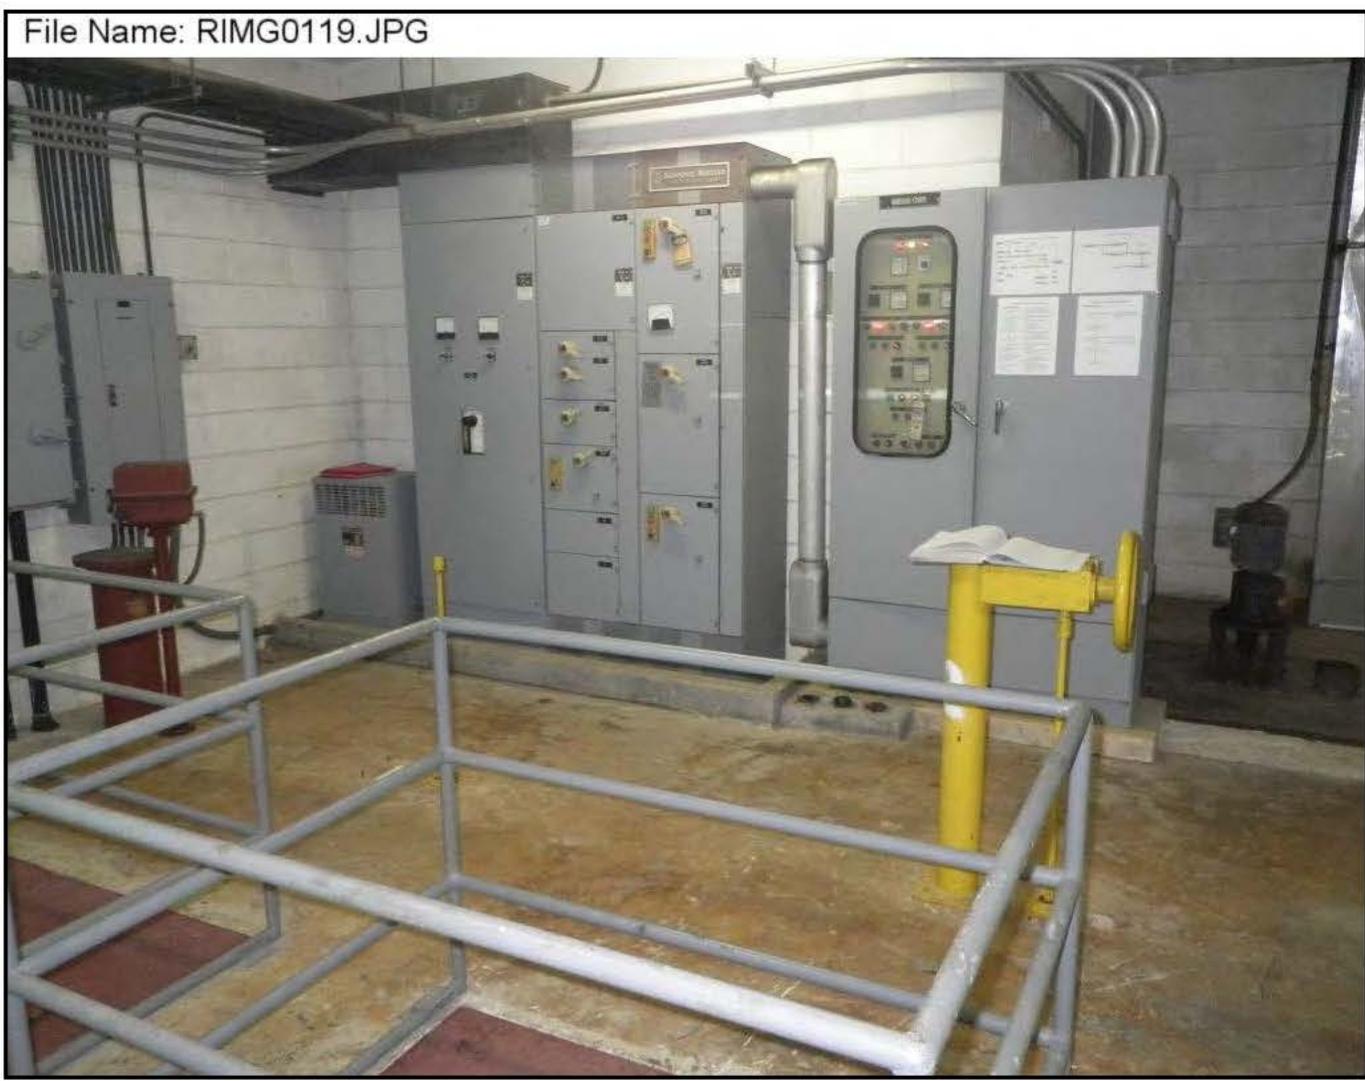
Attributes	
Title	Guam Waterworks Authority (VP0989)
Subject	CWA Collection System
Date Time Stamp	5/1/2012 11:52:02 AM
Photographer	D. Vanlerberghe
Description	Mamajanao pump station controls.

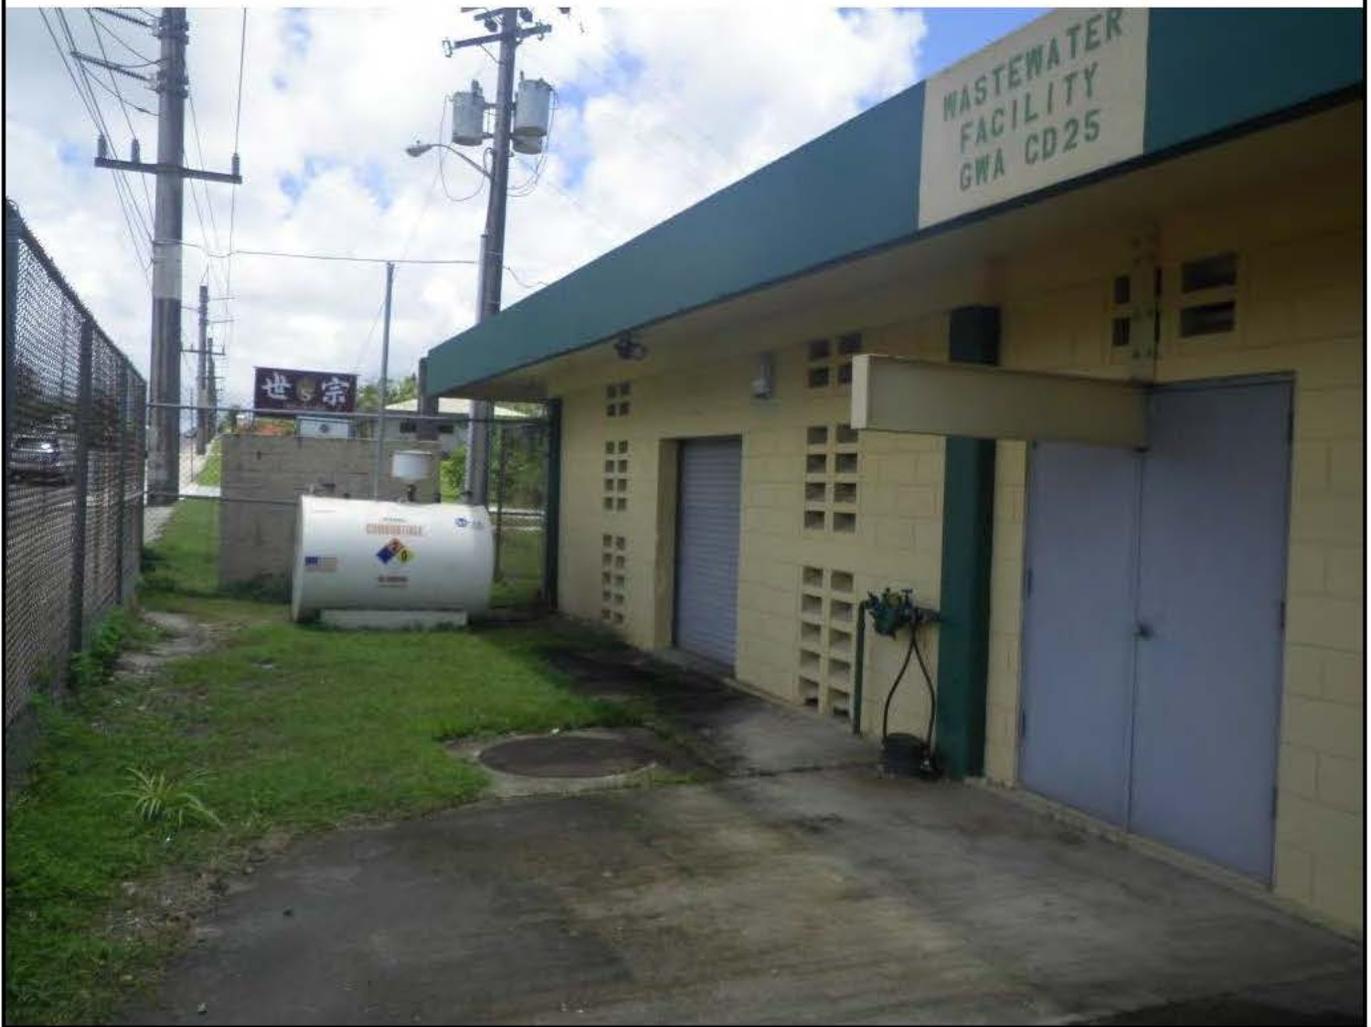
File Name: RIMG0123.JPG

Title	Guam Waterworks Authority (VP0989)
Subject	CWA Collection System
Date Time Stamp	5/1/2012 11:57:22 AM
Photographer	D. Vanlerberghe
Description	Mamajanao pump station diesel fuel tank.

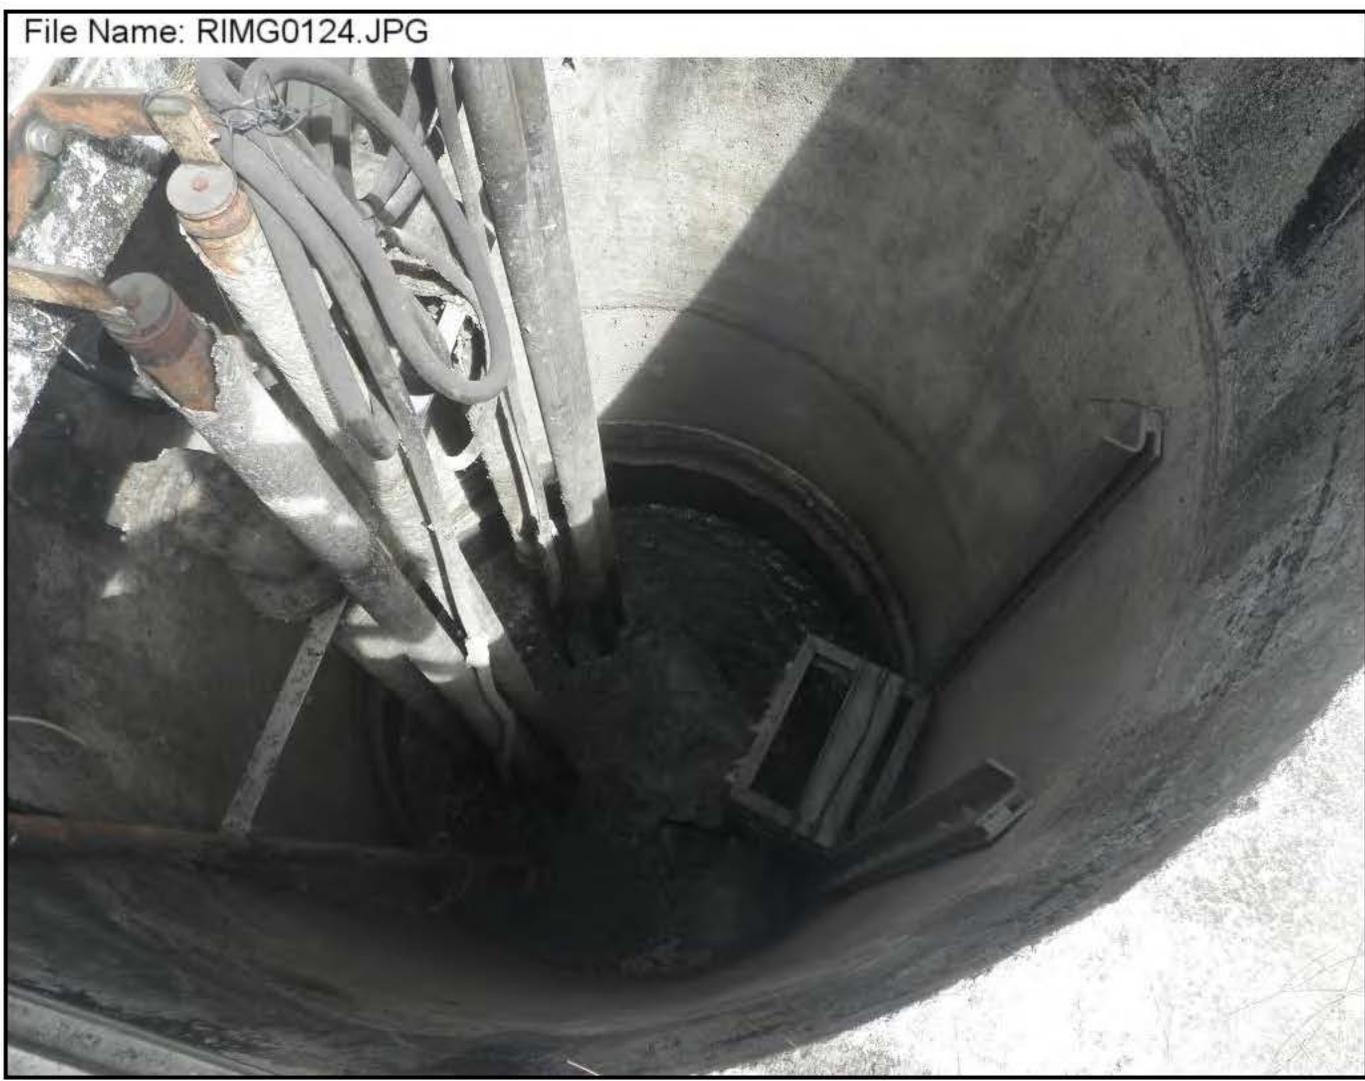
Attributes	
Title	Guam Waterworks Authority (VP0989)
Subject	CWA Collection System
Date Time Stamp	5/1/2012 2:17:43 PM
Photographer	D. Vanlerberghe
Description	Harmon pump station wet well.

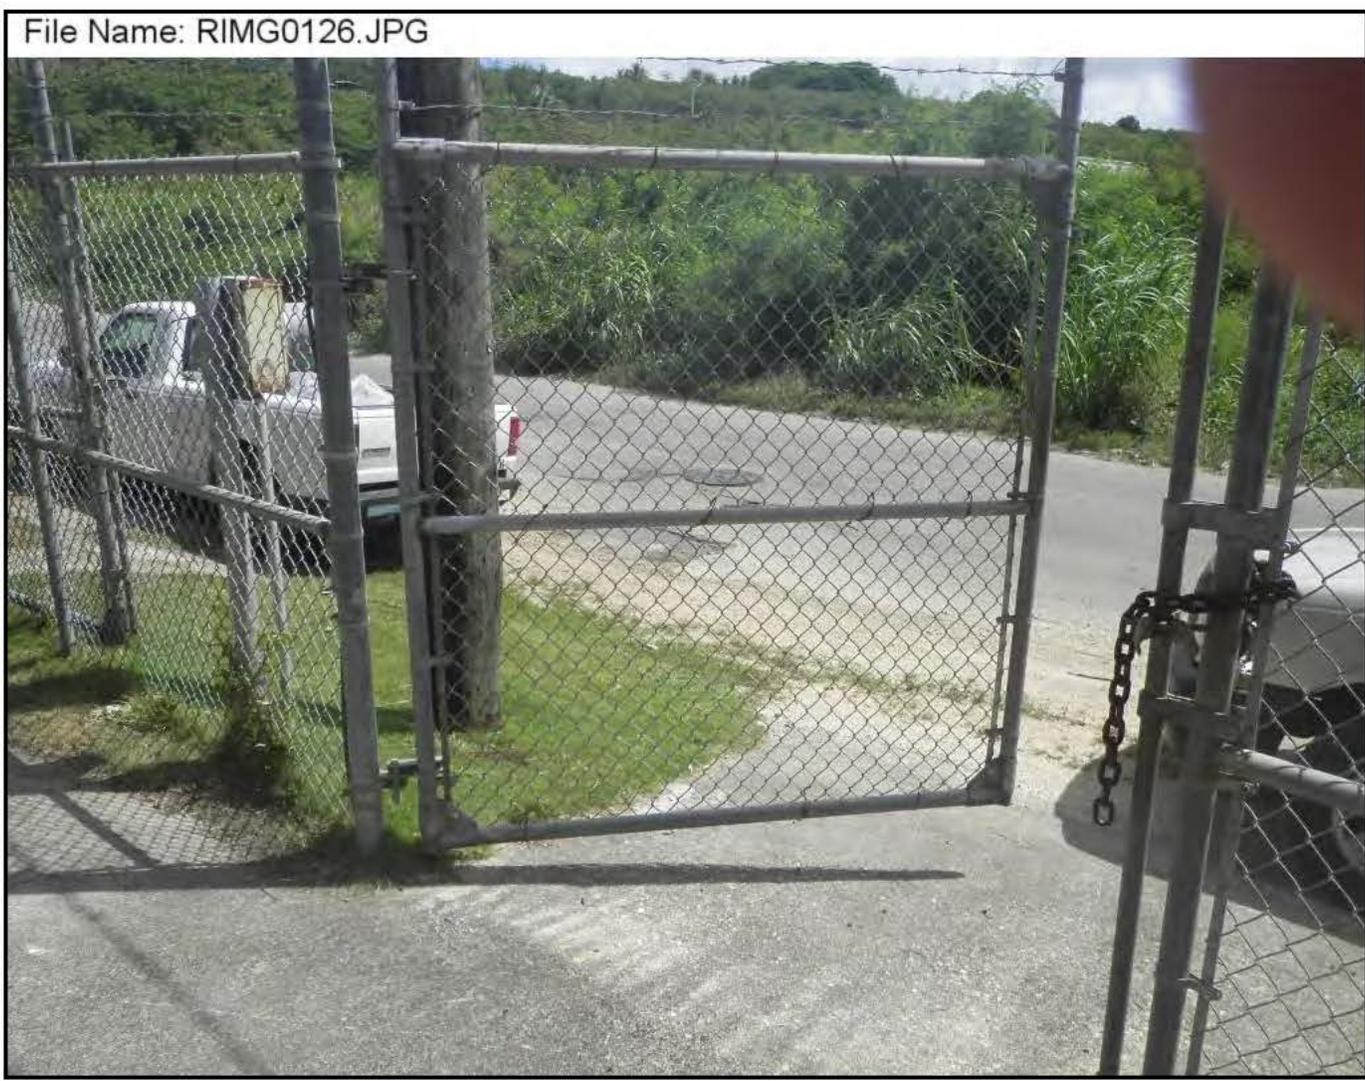
Attributes	
Title	Guam Waterworks Authority (VP0989)
Subject	CWA Collection System
Date Time Stamp	5/1/2012 2:22:20 PM
Photographer	D. Vanlerberghe
Description	Harmon pump station manhole subject to overflows.

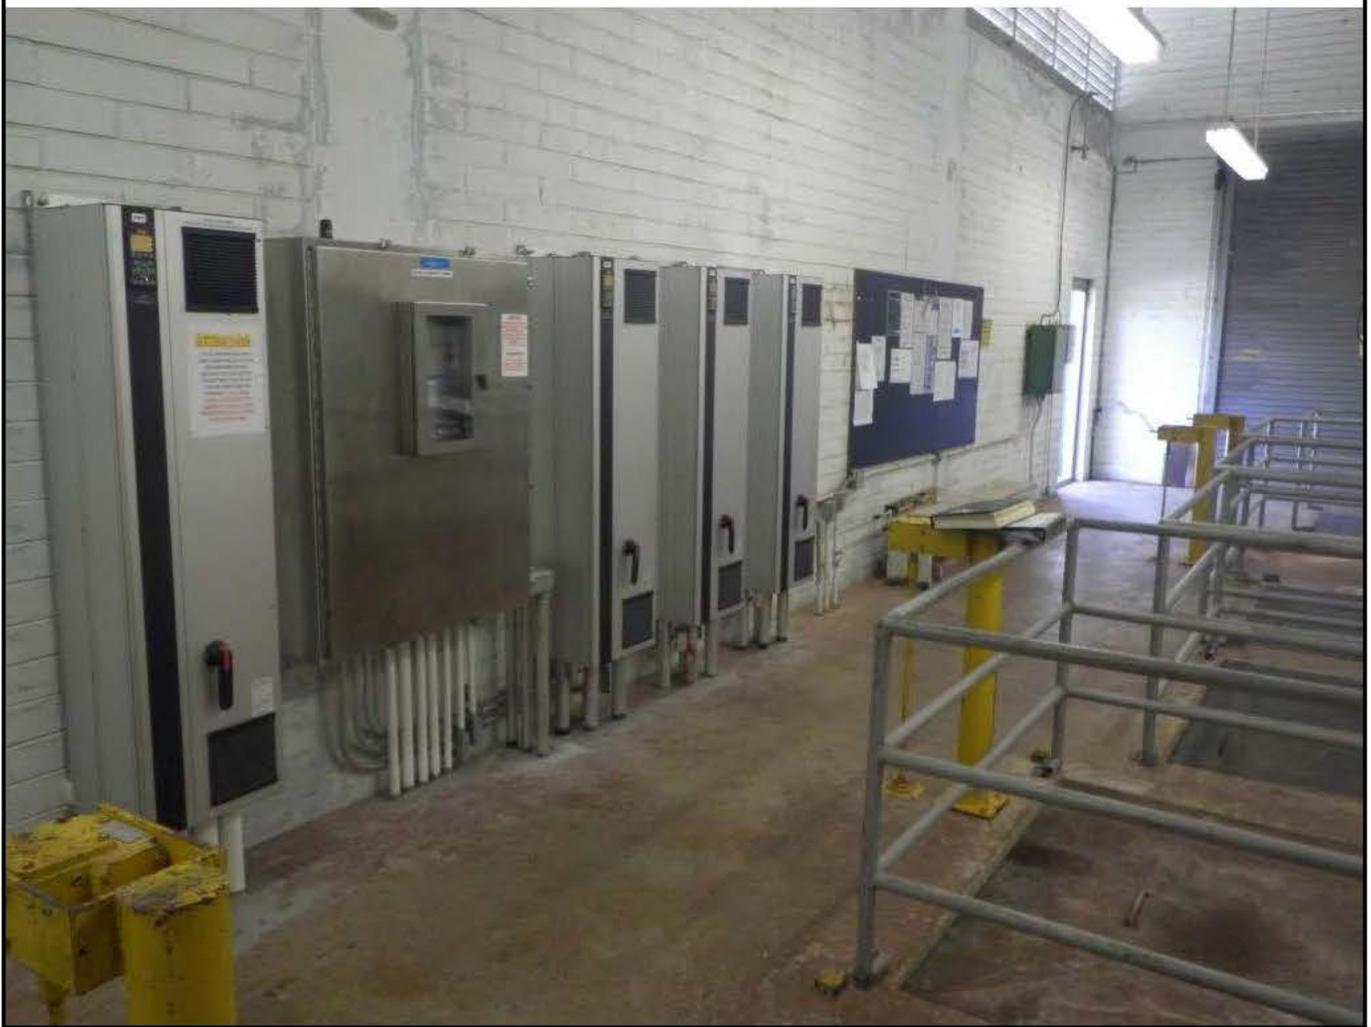
File Name: RIMG0131.JPG

Title	Guam Waterworks Authority (VP0989)
Subject	CWA Collection System
Date Time Stamp	5/1/2012 2:49:18 PM
Photographer	D. Vanlerberghe
Description	Southern Link pump station controls and telemetry.

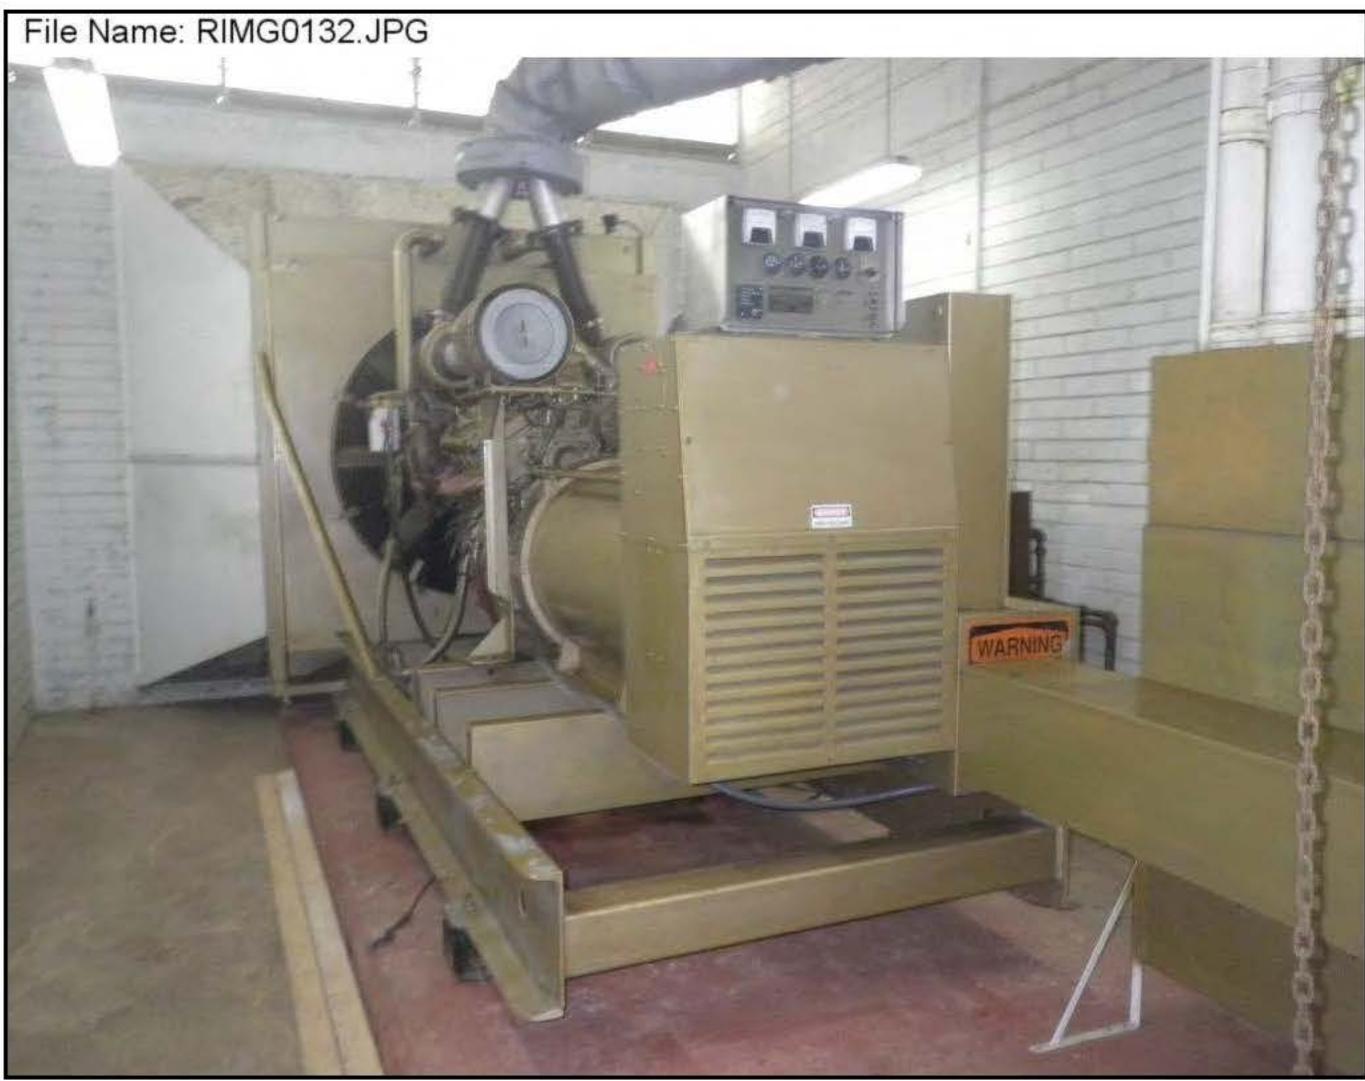
Attributes	
Title	Guam Waterworks Authority (VP0989)
Subject	CWA Collection System
Date Time Stamp	5/1/2012 2:49:58 PM
Photographer	D. Vanlerberghe
Description	Southern Link pump station standby generator.

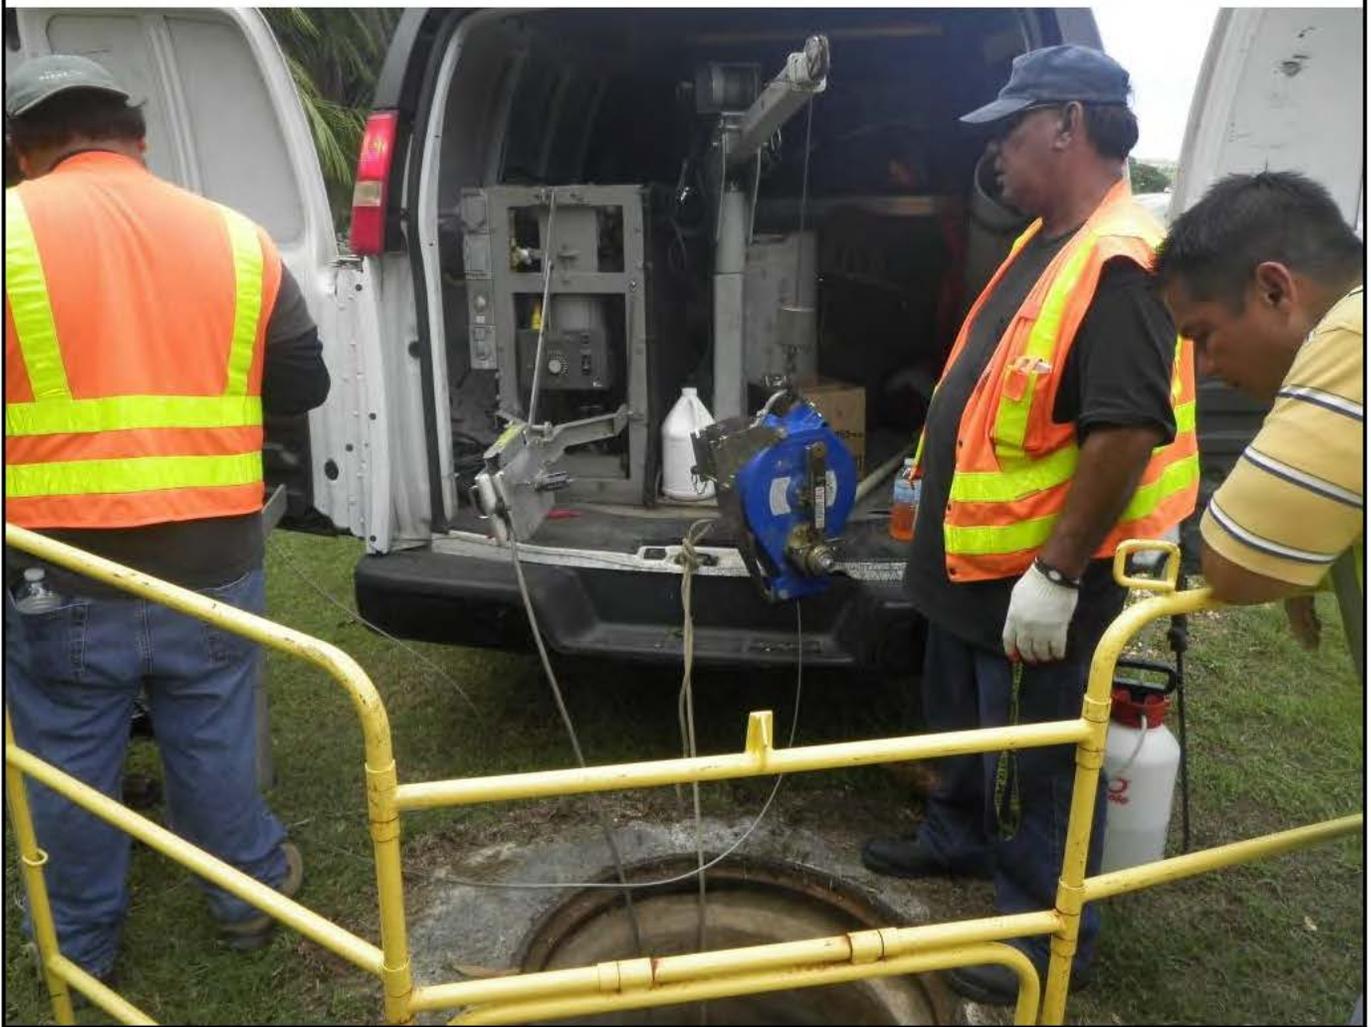
File Name: RIMG0138.JPG

Title	Guam Waterworks Authority (VP0989)
Subject	CWA Collection System
Date Time Stamp	5/2/2012 10:09:38 AM
Photographer	D. Vanlerberghe
Description	CCTV truck, motorized winch out of service.

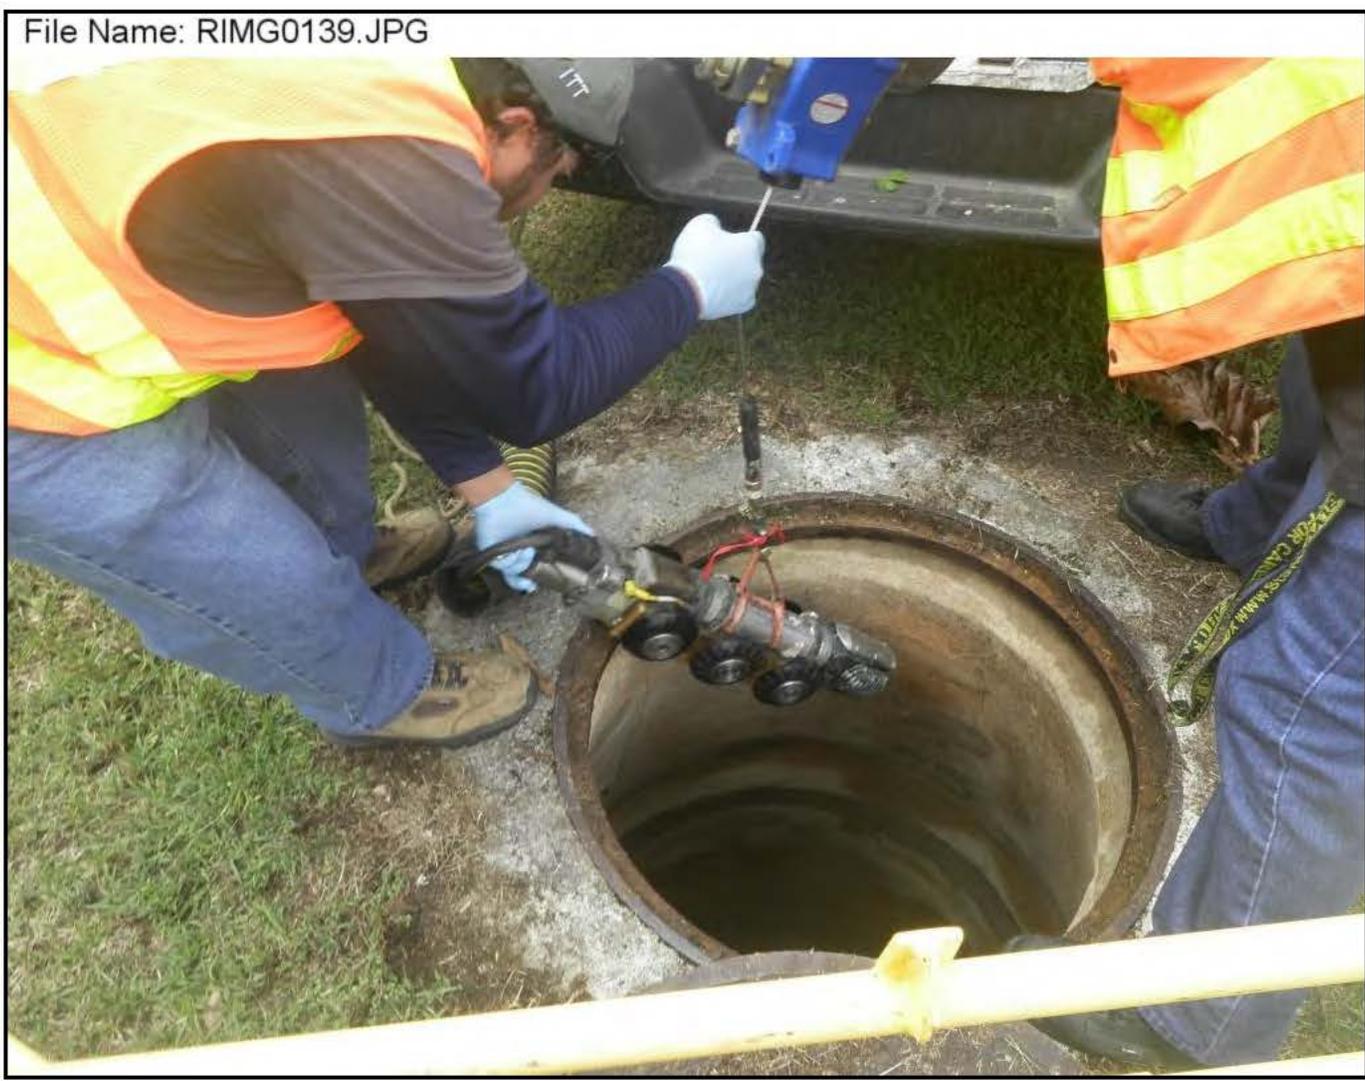
Attributes	
Title	Guam Waterworks Authority (VP0989)
Subject	CWA Collection System
Date Time Stamp	5/2/2012 10:12:14 AM
Photographer	D. Vanlerberghe
Description	Retrieval of CCTV camera from manhole.
